## Experimental investigations into SGP laminated glass under low velocity impact

Wang, Xing-er; Yang, Jian; Liu, Qiang; Zhao, Chenjun

Wang, X, Yang, J, Liu, Q & Zhao, C 2018, 'Experimental investigations into SGP laminated glass under low velocity impact', *International Journal of Impact Engineering*. <https://doi.org/10.1016/j.ijimpeng.2018.06.010>

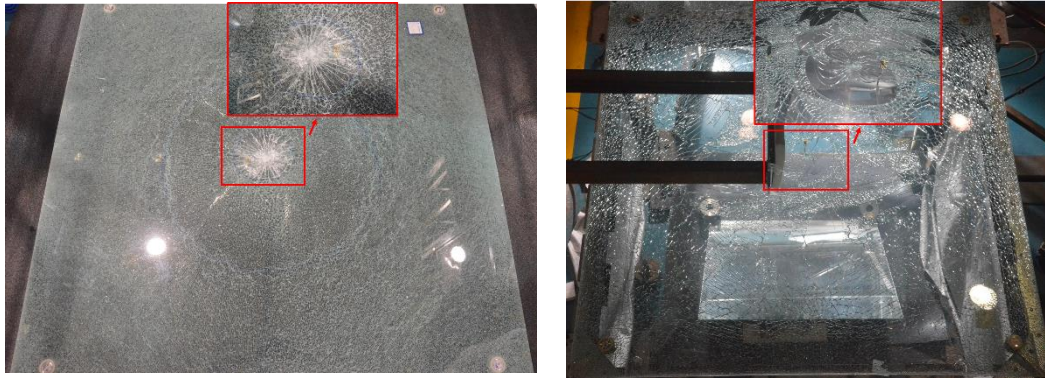
(a) Two glass crack patterns in BS3 at 1<sup>st</sup> breakage

(b) Outer glass crack pattern in BS1 at 1<sup>st</sup> breakage

**Fig. 11.** Crack patterns of specimen No. 2 at first breakage.
